June 21, 1999

Mr. Ed Steffani  
General Manager  
Stockton East Water District  
6767 E. Main Street  
Stockton, California 95205-0157

**Subject: Erosion of Hoods Creek - Whittle and Hertlein Properties**

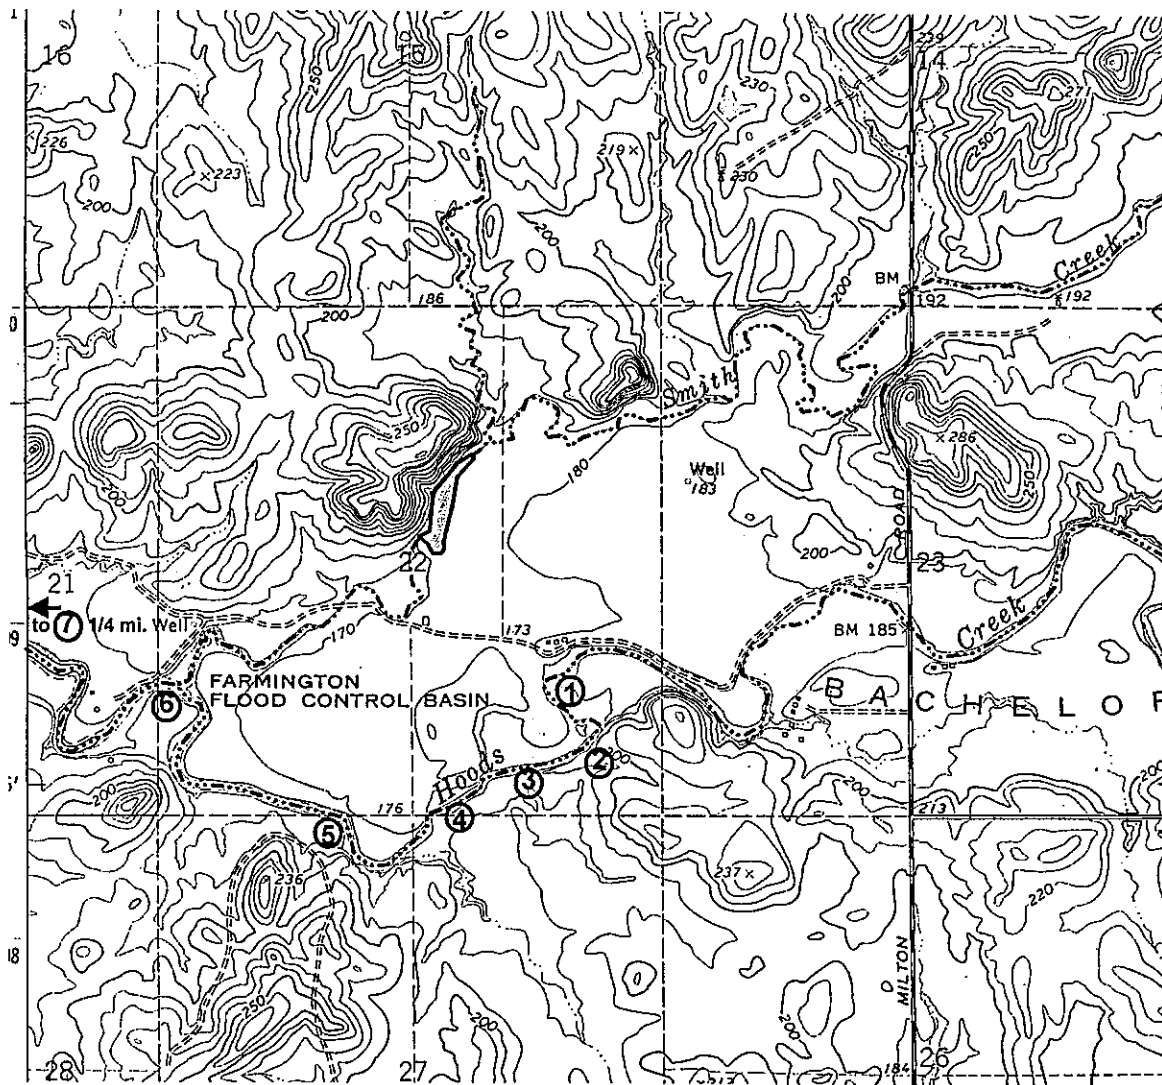
**Figure 1. Locations of sites along Hoods Creek.**

I examined seven sites (figure 1), within reaches 12, 13 and 14. These reaches were identified in the 1989 report as being among the most stable in the Shirley/Hood/Rock Creek system, and those least likely affected by SEWD's instream conveyance program.

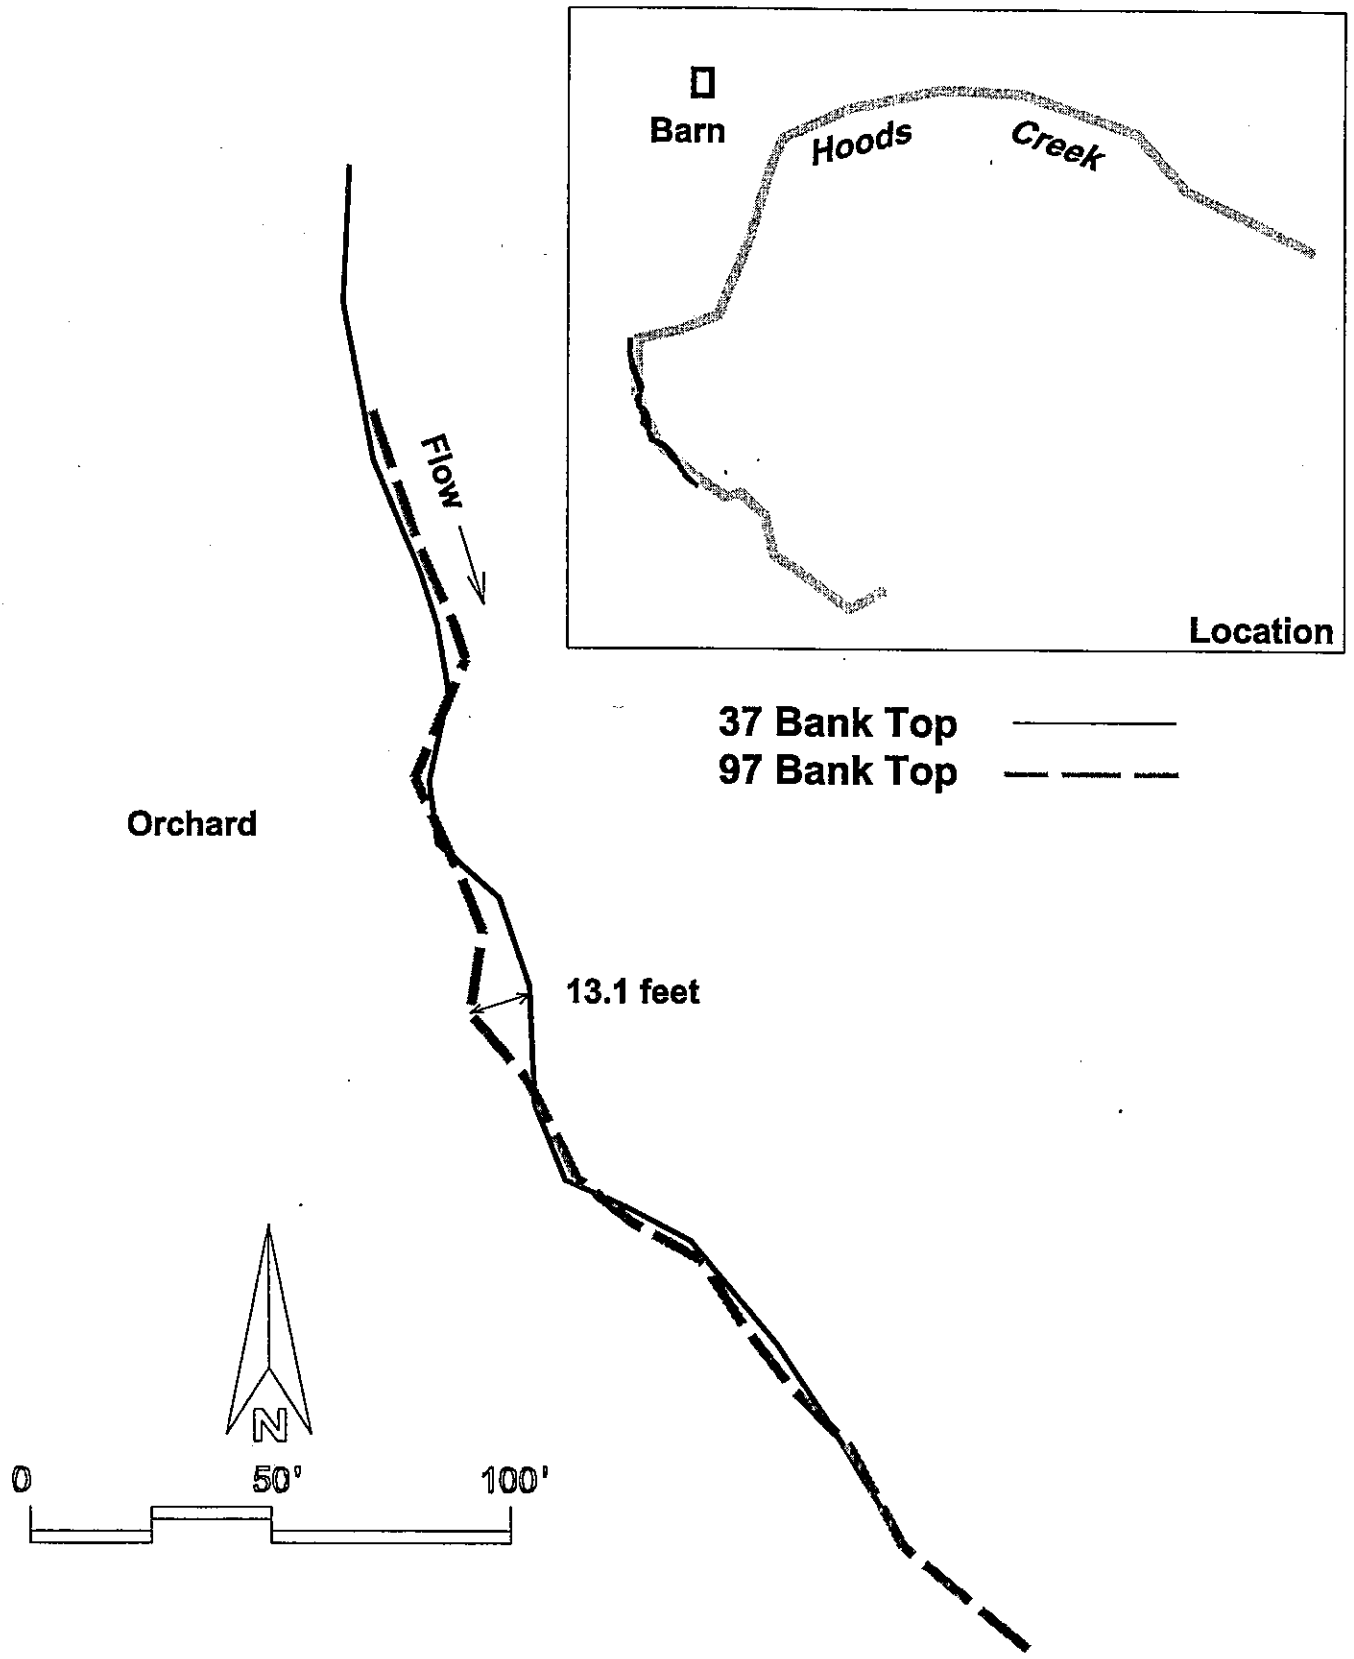
The most critical site visited was in the vicinity of a 90-degree bend in the channel on the east side of the Hertlein property near the Oliver residence and barn. On the high, steep bank just downstream of the bend, a wedge of soil collapsed, eroding away approximately 20 lineal feet of upper bank material from beneath the barbed-wire fence, which is now suspended across this gap. This erosion most likely occurred during a period of extremely high water, such as the flood flows experienced this past winter. One of the fenceposts has been washed away. The top of the bank seems to have retreated approximately 8 feet during this one event, to a position 31.4 feet from the base of the trunk of the nearest walnut tree, and about 21 feet from the top of the collapsed bank to its drip line. The intervening distance is occupied by the unimproved service road essential to the operation of any orchard.

*Ongoing processes and suggested actions -- whole-bluff scale:* Conditions at this site suggest that it may be useful and helpful to focus on the processes affecting the whole bluff, rather than focusing on the localized failure. Therefore, since last meeting with the SEWD Board and the owners, our staff has tried to obtain any and all additional information pertinent to this complex site. The Hertleins have also attempted to learn more about the evolving position of the bank through discussions with neighbors and review of property records. Neither search has yielded much in the way of tangible data either identifying the location of the bank or any major changes in stream location or conditions. Our staff then took the next step of using high-resolution analysis of enlarged aerial photographs to estimate the rate and pattern of bank retreat at this site between 1937 and 1997. We purchased additional aerial photography from 1937 centered over this site to minimize photographic distortion. Custom enlargements were made of both the 1937 and 1997 aeriels, so that position of the banktops could be analyzed at various scales, including some as detailed as 50 feet to the inch. Results, depicted in Figure 2, indicate that (a) as much as 13 feet of retreat may have occurred during the past 60 years at the localized failure, inclusive of the estimated 8 feet reported in 1997, (b) retreat elsewhere along this bluff has generally been two feet or less, comparable to the discrimination errors inherent in interpretation of hyper-enlarged aerial photography. It is likely that (c) a prior bank retreat event occurred at the localized failure, an inference consistent with evidence of an older fenceline the presence of an older north-south fenceline a few feet east of the existing barbed wire; and (d) no evidence can be found for similar collapses elsewhere along the bluff.

Rates of bank retreat, averaged over 60 years, range from about 0.4 inches per year for most of the bluff to a maximum of about 2.6 inches per year at the localized failure.

**Figure 2. High-resolution comparative map of top of bank at Hertlein's orchard, 1937 and 1997. Maximum retreat of approximately 13 feet is associated with a bank collapse reported during the winter of 1996-97. Other areas show change on the order of 2 feet or less, or about 0.4 inches or less per year.**

- (d) a preferred approach at this site would include a tiered set of actions:
- move the fence back several feet from the existing top of bank, such that use of the service road around the periphery of the orchard is safer,
  - plan for additional bank retreat of up to 5 to 10 feet during the next few decades,
  - consider repair of the bank with a shallow retaining wall anchored in the upper 8 to 10 feet of the red terrace deposits if retreat beyond 10 feet occurs, threatening long-term use of the orchard service road.
