June 21, 1999

Mr. Ed Steffani  
General Manager  
Stockton East Water District  
6767 E. Main Street  
Stockton, California 95205-0157

**Subject: Erosion of Hoods Creek - Whittle and Hertlein Properties**

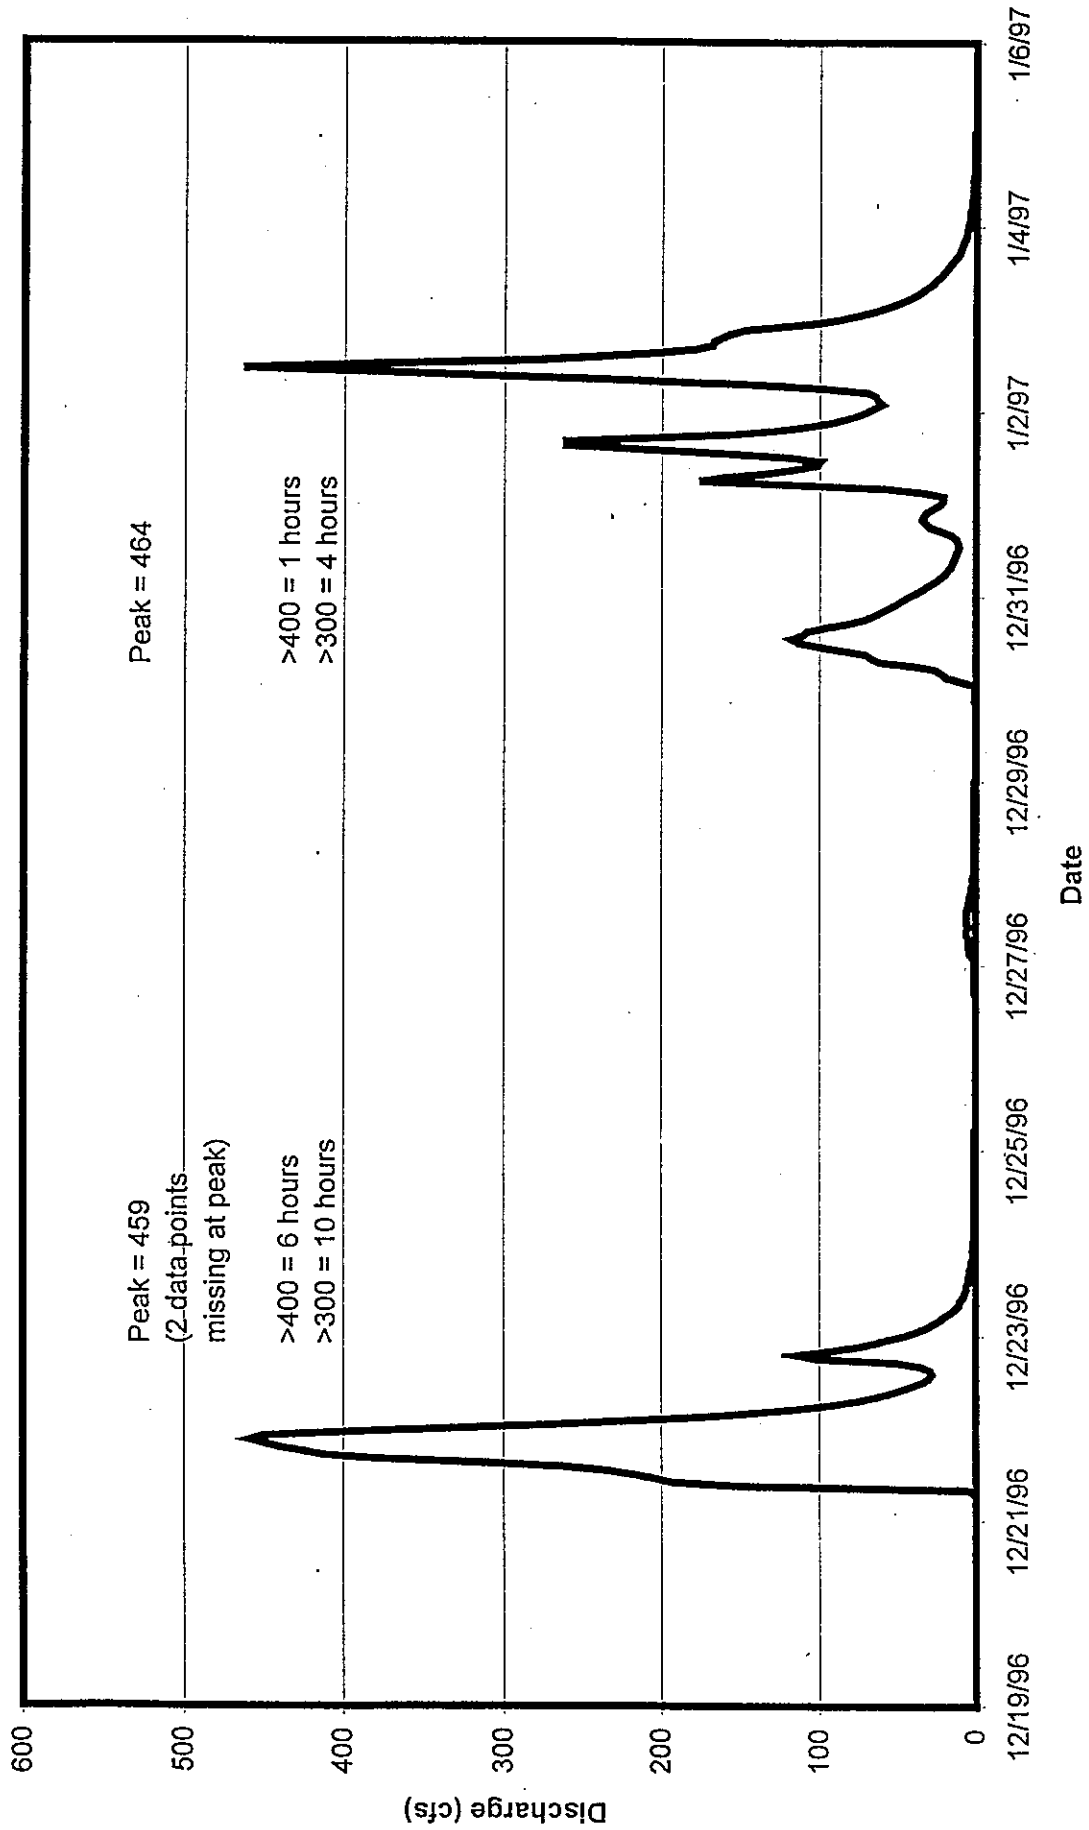
# Discharge at USACE Gage on Duck Creek near Farmington December 19, 1996 to January 6, 1997

1. Major peak flows on Hoods Creek in December 1996, January 1997, and February 1998 tested the stability of the channel. It appears that peak flows during the winter of 1996/7 were the highest or among the highest since inception of local record-keeping in the early 1930s. With some specific exceptions, the banks and beds exhibited a high level of stability under major-flood conditions.
2. Flood-relief flows conveyed through SEWD's facilities at the request of the USBR were made during late January through early March 1997. The flows were about 10 percent of the peak flows which occurred presumably in early January, before the diversions commenced, and there is no evidence that they played a major role in bank erosion or retreat during the winters of 1996/7.

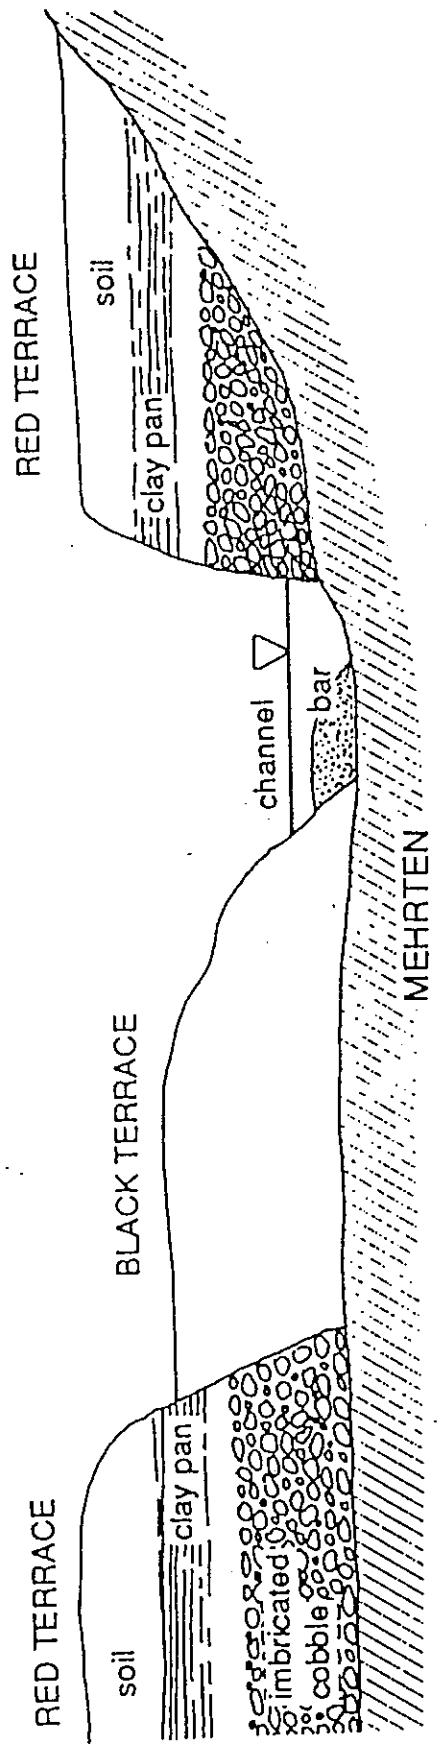
Figure 6. Typical Low-Bank Mehrten Occurrence

3. I observed the three very different patterns of erosion developing in the three rock types -- Mehrten formation, Red Terrace and Black Terrace -- anticipated in our 1989 report; no need to change or update our descriptions of these patterns was evident.
